Water Quality Pilot Study for Traditional Water Structure Revitalization Potential in the Deccan Plateau of India

Jonathan Bessette¹ and Eric Niblock²

¹School of Engineering and Applied Sciences, ²College of Arts and Sciences, University at Buffalo, SUNY, Buffalo, NY 14260, United States, Email: jbessett@buffalo.edu, ericnibl@buffalo.edu

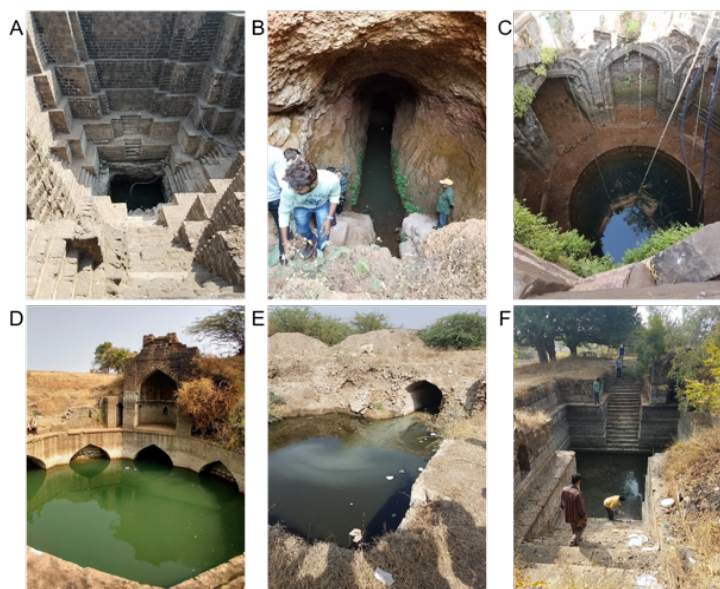
Figure 3: Examples of traditional water structure sample sites (a) Daulatabad Fort; (b) Bidar karez; (c) Bidar Fort; (d) Chaukhandi; (e) Shahpur Karez Mother Well; (f) Ashtoor.

Figure 3 displays examples of *baoli*, or stepwells, in (a), (c), (d), and (f). *Karez* system components of both the (e) head and the (b) mouth of this underground horizontal canal system are also pictured.

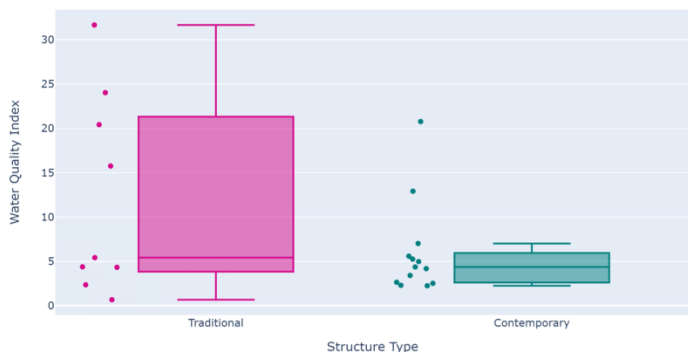
Figure 4: Water structure type versus WQI

Our results regarding the water quality of traditional water structures across the Deccan in comparison to modern municipal sources such as tap water from bore wells is shown in a combined dot and boxplot in Figure 4 below. It appears that contemporary sources have higher water quality than traditional sources when analyzed with our WQI metric. This is theorized to be related to the lack of care and usage of traditional water sites. Some traditional sites shown have WQI levels comparable to contemporary sites, perhaps indicating potential for usage as sustainable agricultural or municipal water sources. There exists significant variance amongst the traditional water structures, likely due to the variation in factors such as pollution, location, usage, and conservation levels.

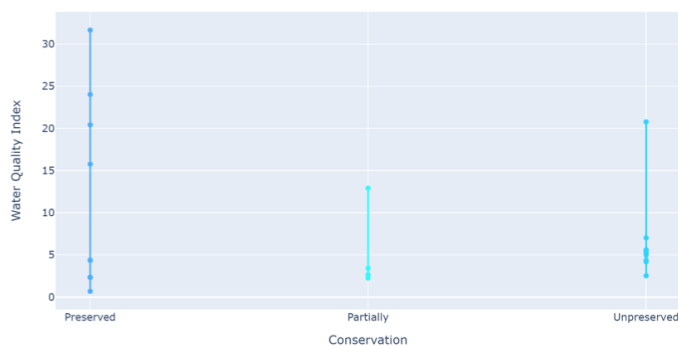
Figure 5: Structure Conservation versus WQI

Exploring the level of conservation amongst all of the sites, we found little relationship between conservation efforts and corresponding water quality. Many preserved sites scored poorly when employing our WQI. Conservation amongst traditional sites, was split into three categories: preserved, partially preserved, and unpreserved. Preserved structures had some level of supervision or oversight, which occurred in a variety of forms including but not limited to religious institutions, tourism, and historic site security. Partially preserved sites were recognized by locals and partially maintained

by the constituents. Unpreserved sites were completely abandoned and had no signs of revitalization or maintenance efforts; most were stagnant, polluted bodies of water. We found that the only preserved site possessed the lowest WQI (thus, the highest water quality). However, some unpreserved sites showed similarly low levels of WQI. The variation in the data and lack of sample size makes it difficult to conclude the effect of conservation on water quality, as seen in Figure 5.

We hypothesize that no strong correlation between conservation efforts and lower water quality index (more potable water) is due to a continuation of past contamination practices by some residents, and nonpoint source pollution (NPS). Maintained sites typically are not able to afford constant protection via gates or guards; thus, we observed some municipal waste at even highly conserved sites. Less easily discernible is the possibility of NPS such as excess fertilizer, urban runoff, sediment, salt from irrigation, and atmospheric deposition. Understanding NPS is especially essential for groundwater in agricultural regions such as the areas of rural India we sampled (Kourakos, Klein, Cortis, and Harter 2012). NPS as a confounding factor on water body revitalization is not unique; it has been observed in many water sources throughout India (Jha, Singh, Ojha, and Bhatia 2006). However, we also note lack of correlation could be due to small sample size, as well as potential flaws in our classification ontology.

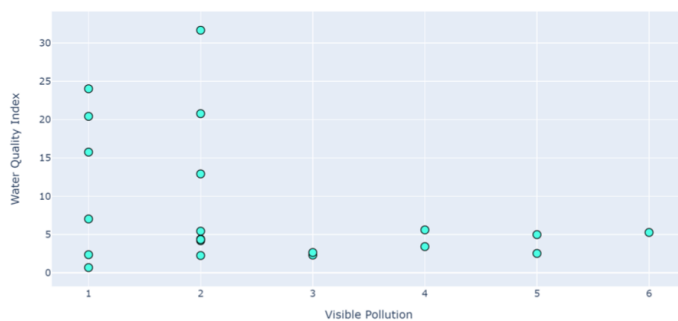
Figure 6: Visible pollution versus WQI

Visible pollution is a metric taken based on the average of two individuals observing the site in the field and rating the pollution level on a scale of 10-70, with 70 being the highest level of pollution. It is apparent that the higher visible pollution levels do not show correlation to better or worse WQI levels as seen in Figure 6.

Interestingly, we notice even the most visibly “clean-looking” water sources can contain the most harmful substances in the forms of heavy metals, high levels of

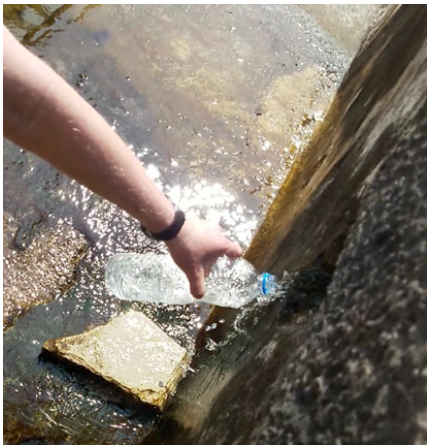
Figure 7: Sample from the Kumatgi Hauz

The most potable water occurred at the Kumatgi Hauz, one of the more isolated sites which corresponded to a visible pollution rating of 2 and a partially preserved level of conservation (Philon and Arni 2014). It was in a relatively flat area likely fed by the nearby artificial reservoir. It is hypothesized that its location—farther from major populations than other structures we visited—aided in the mitigation of pollution and bolstered the low WQI.
